Learning from failure: Damage and Failure of Masonry Structures, after the 2017 Lesvos Earthquake (Greece)

Georgios Vlachakis, Evangelia Vlachaki, Paulo B. Lourenço

To appear in: *Engineering Failure Analysis*

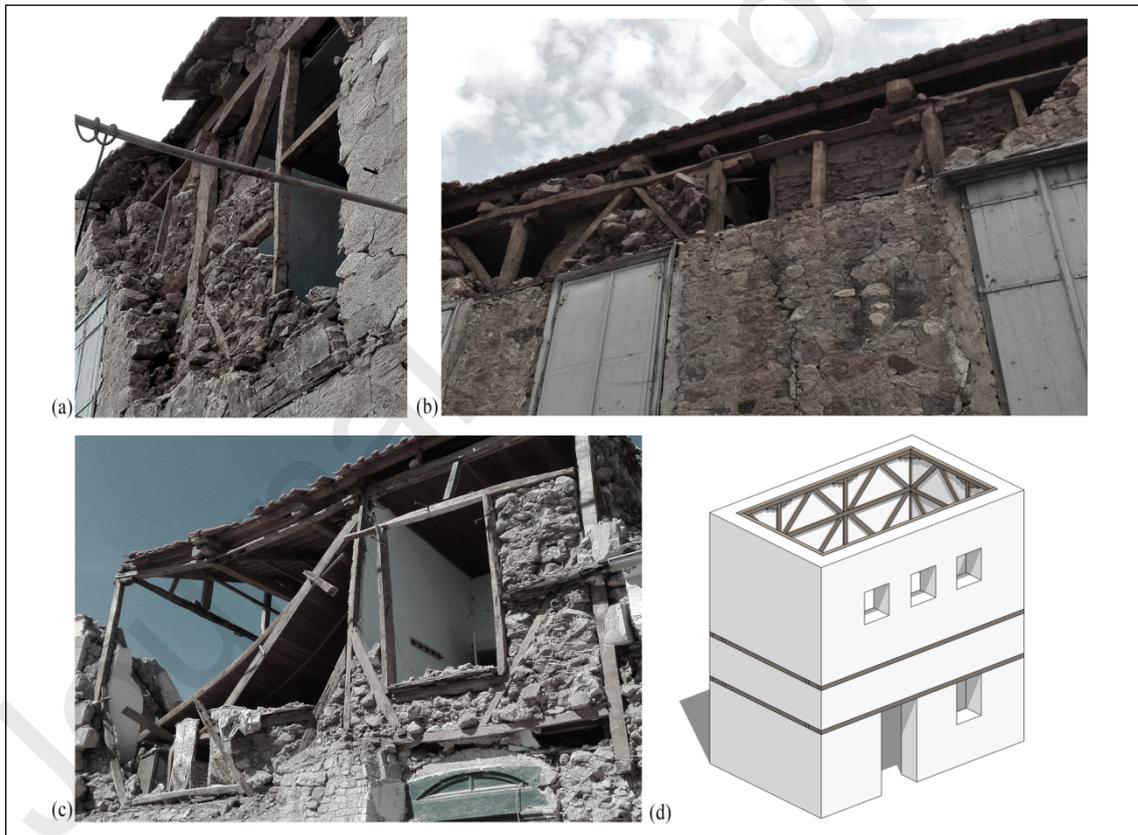
231 collapse of the roof system, thus protecting the buildings' inhabitants. Yet, one could argue
 232 that such OOP failures could have been prevented if the timber-frame was also confining the
 233 outer leaf with timber-laces at regular distances. Furthermore, it should be noted that the
 234 damage was much more extensive in cases with deficiencies, such as the irregular
 235 configuration of the braces, the lack of continuity of the timber-frame at the ground floor,
 236 the presence of poor connections or the level of degradation of the timber (Figure 7 (c)).

Figure 7. (a)-(b) Localized out-of-plane collapse of external unreinforced leaf. Notice the L-shaped corner elements in (b). (c) Extensive damage due to timber deterioration and poor connections. Notice the lack of the timber-frame system at the ground floor. (d) Schematic sketch of timber-frame masonry.

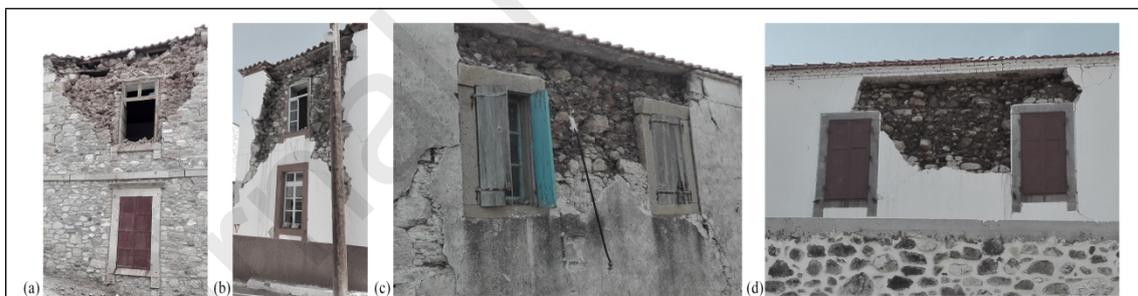
252 Disintegration of masonry can be considered a local mechanism in essence. In literature, it is
 253 also referred to as the “zero” mechanism [26], appearing when a masonry portion is unable
 254 to counteract almost any horizontal action and crumbles into pieces. Many cases of
 255 disintegration were identified during the reconnaissance, mainly as delamination of the
 256 external leaf (Figure 3, Figure 4 and Figure 8). The main factors that triggered such
 257 mechanisms are related to the low quality of the materials, the lack of interlocking stones of
 258 the different leaves or the lack of connection of the leaves with timber-laces.

Figure 8. (a)-(d) Local failures of the external leaf due to wall disintegration.

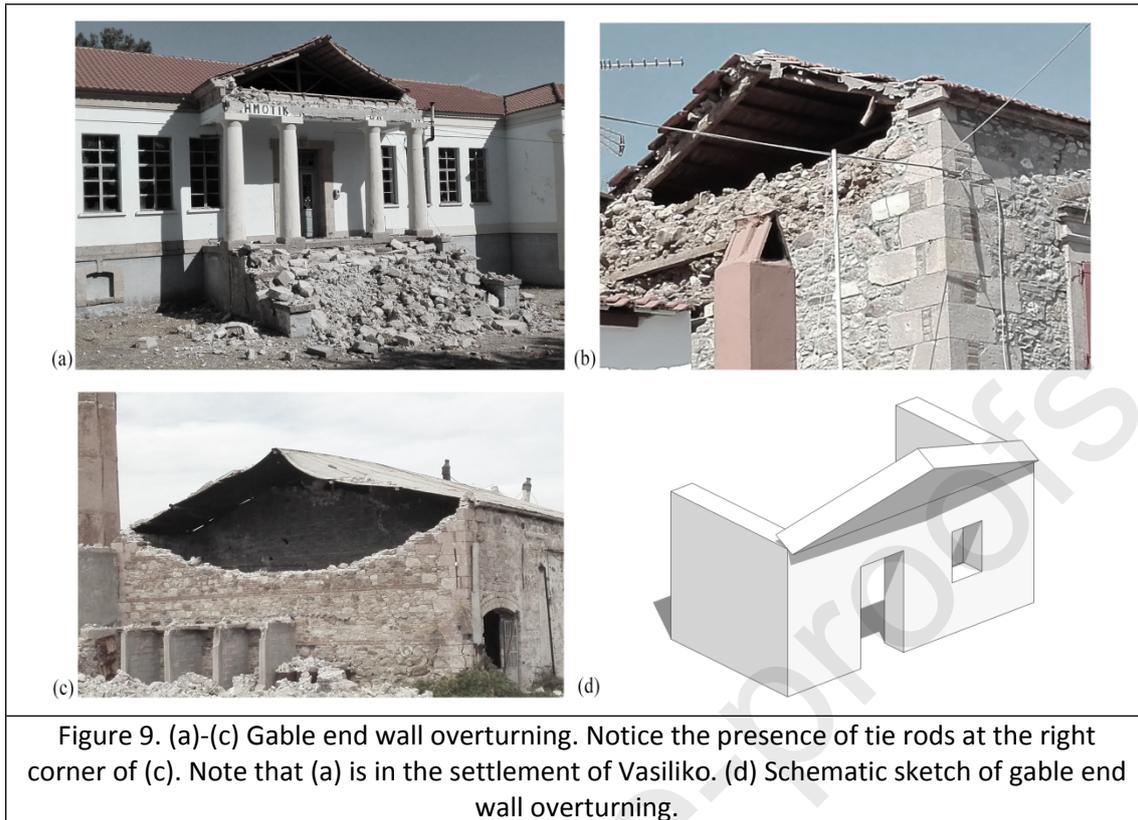
260 Overturning of gable end walls is a frequently occurring local mechanism. The notable
 261 vulnerability of this part of the constructions is attributed mainly to the inadequate
 262 connection with the roofing system and the lack of overburden weight (as the roof rafters
 263 are usually laid on the transversal walls), together with the amplified accelerations at the
 264 gable’s height. Several collapses of gable walls were observed during the reconnaissance
 265 (Figure 9). Among them, it is worth to mention the gable wall collapse of the elementary
 266 school of Vasiliko, a settlement of around 7km further inland from Vrissa which suffered
 267 almost no damage. This further highlights the vulnerability of the mechanism (Figure 9 (a)).

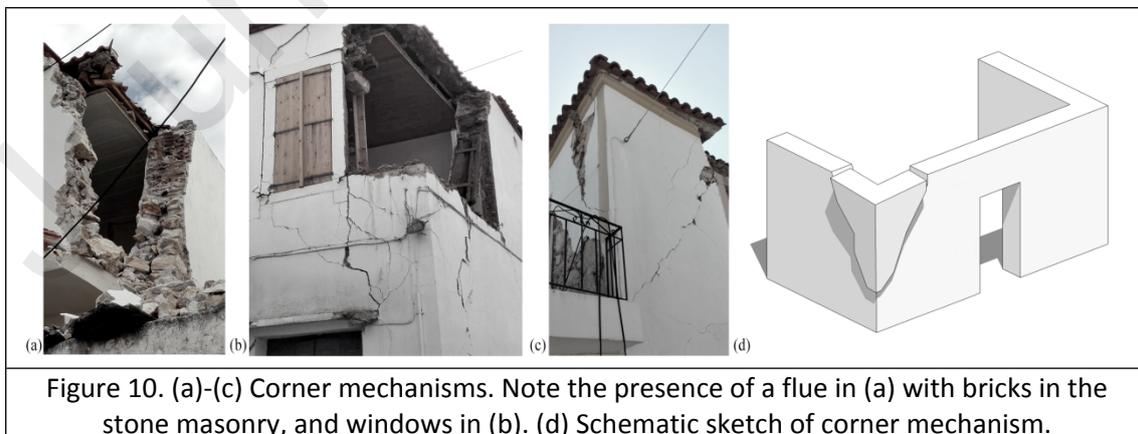
269 Another common local mechanism concerns the top part corners of buildings (Figure 10).
 270 This mechanism originates from the lack of a diaphragm; often in presence of adequate
 271 connections by the quoin-stones, preventing façade detachment and overturning [48,49]. As
 272 a result, a combination of IP rocking-sliding and OOP flexural failure occur, forming wedge
 273 type diagonal cracks. Furthermore, the vulnerability of this mechanism is increased by the
 274 presence of a thrusting roof, and neighboring openings or flues at the transversal walls.
 275 Finally, it should be noted that the occurrence of such mechanism reduces significantly the
 276 capacity of the connecting transversal façades, as they lose a vital transversal support.

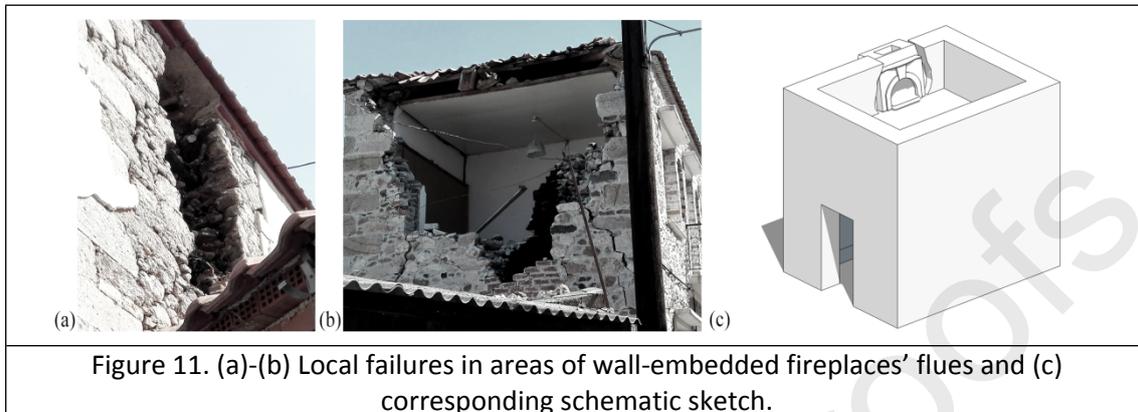
278 Local failures were also observed in areas of fireplaces' flues (Figure 11). The usual
 279 configuration of embedding the fireplace's flue within masonry induces a local section

280 reduction at the wall that makes it much more vulnerable. It is noted that the material
 281 degradation caused by the fire and cycles of thermal expansion / contraction further reduces
 282 the capacity. Moreover, the vertical discontinuity introduced by the section reduction, could
 283 trigger other mechanisms as well.

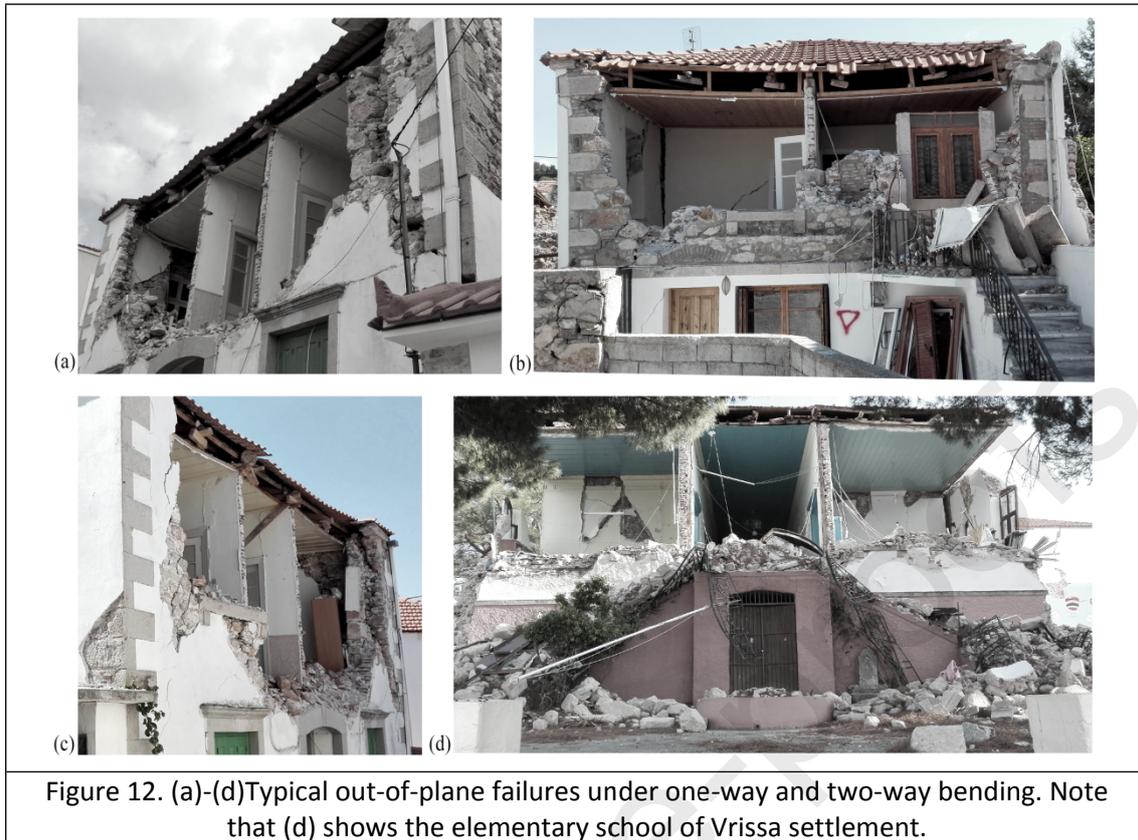
290 Long walls or walls with insufficient transversal support suffer vertical, one-way bending. In
 291 particular, the top part of the façades, usually inadequately connected with the roof,
 292 behaves as a cantilever about their base or the underneath floor level (rocking type of
 293 failure). Similarly, walls with adequately connected transversal walls experience two-way
 294 bending, characterized by larger capacity in comparison with the former. Figure 12 depicts
 295 typical OOP collapses.

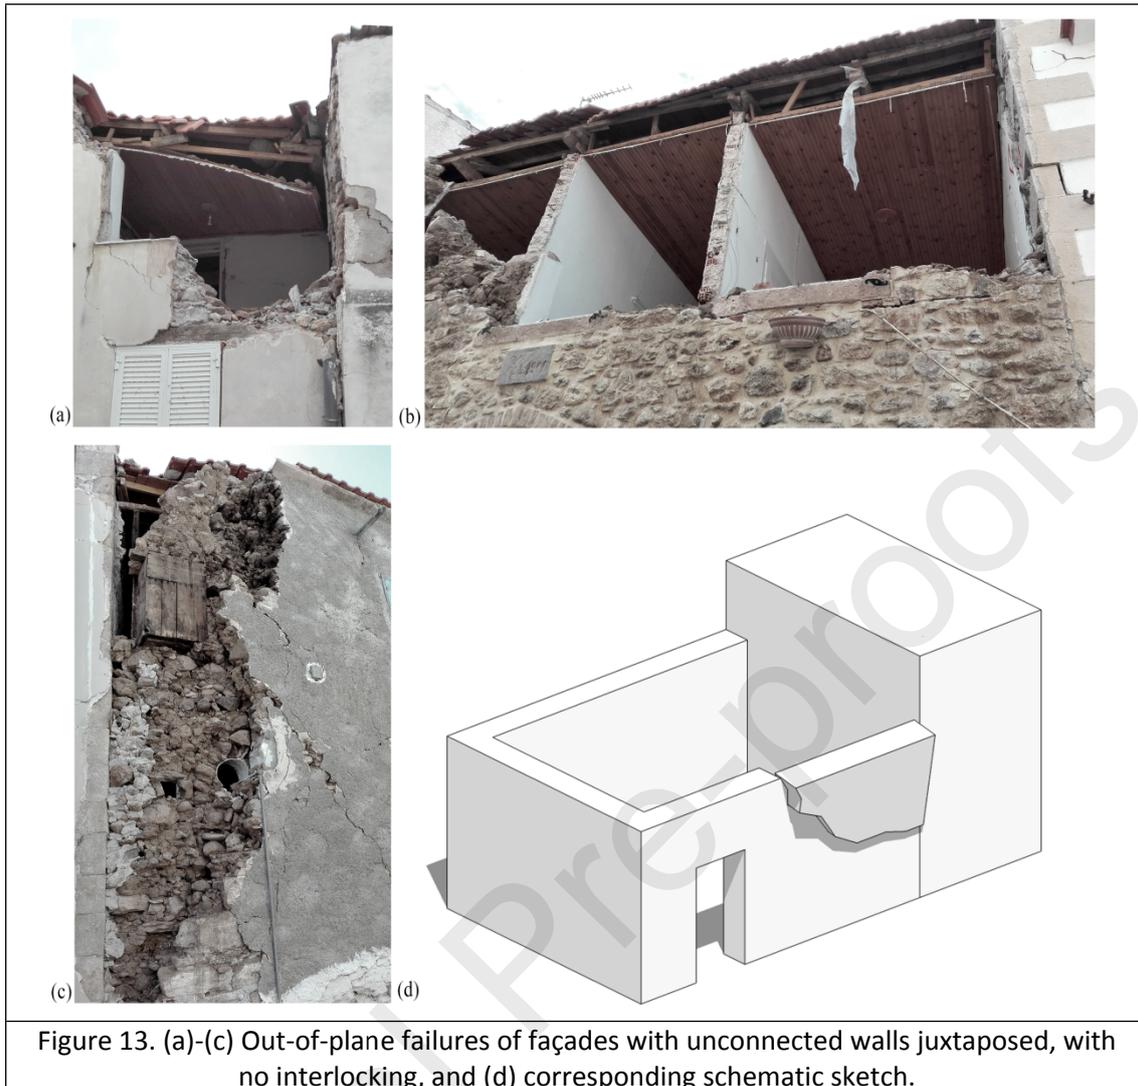
297 The typical plan layout of the constructions in the area contributed to the development of
 298 one-way OOP bending. Since the internal walls were not connected with the masonry walls,
 299 the resulting unconstrained length of the façades (around 10 m) was too large. Several cases
 300 were observed in which one intermediate wall was shared between two structural units; yet
 301 one of them was just resting on the common wall, lacking connection. Such configuration
 302 usually appears when the two units were built at different periods, and the latter unit
 303 increased the internal space by utilizing the existing wall. The seismic vulnerability of such
 304 configuration is clear from a structural point of view, as the transversal façade of the latter
 305 unit lacks a lateral support (Figure 13). A traditional solution in such cases is the insertion of
 306 protruding (or “toothing”) stones to ensure interlocking, although this was not observed in

Figure 13. (a)-(c) Out-of-plane failures of façades with unconnected walls juxtaposed, with no interlocking, and (d) corresponding schematic sketch.

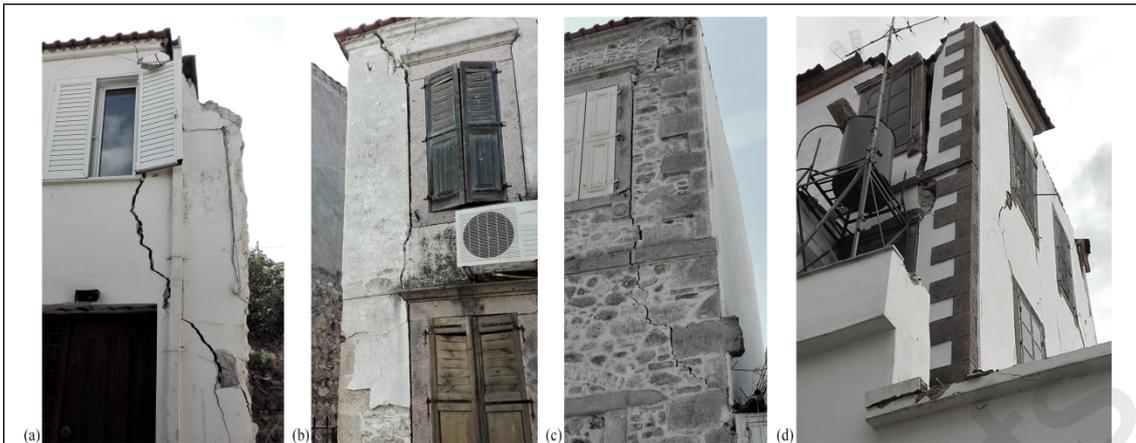
Figure 14. (a)-(d) Weak connection of transversal walls, due to the presence of openings at the corner proximity.

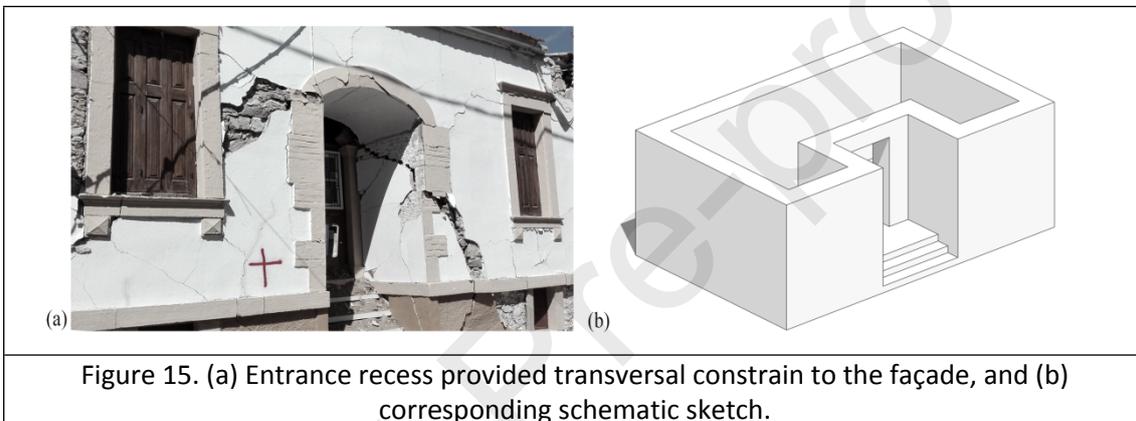
319 for the façades, introducing flanges (Figure 15). A representative example is shown in (Figure
 320 15 (a)), where the transversal walls of the entrance recess suffered IP damage, indicating
 321 their role of supporting the main façade. Nevertheless, this attribute was only effective for
 322 the ground floor.

Figure 15. (a) Entrance recess provided transversal constrain to the façade, and (b) corresponding schematic sketch.

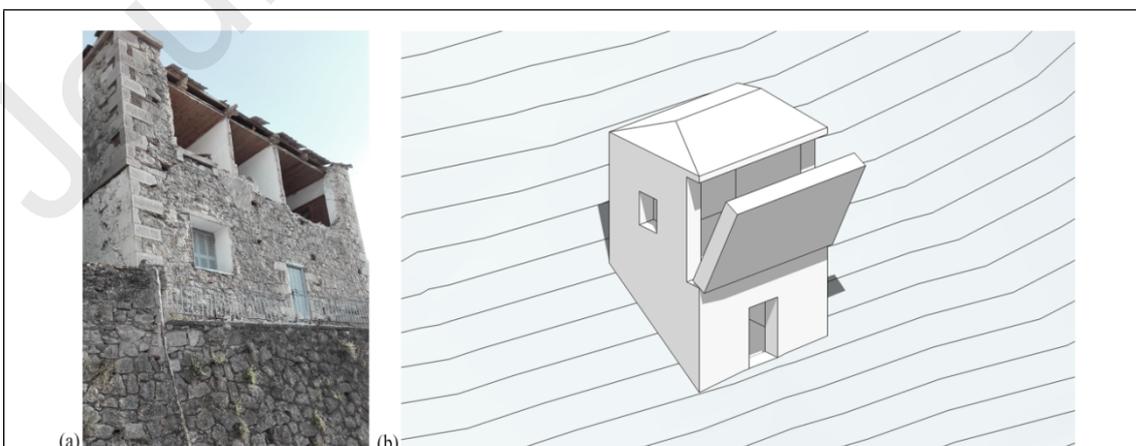
325 The vulnerability of the masonry walls is also governed by the slenderness, with more
 326 damage for walls with higher interstory height. Due to the acceleration amplification across
 327 the height and the lower overburden weight, many OOP collapses of top parts of slender
 328 walls were observed (Figure 12). A representative example of the aforementioned
 329 characteristics can be recognized in slender downhill side façades (Figure 16).

Figure 16. (a) Out-of-plane collapse of downhill side façade, and (b) corresponding schematic sketch.

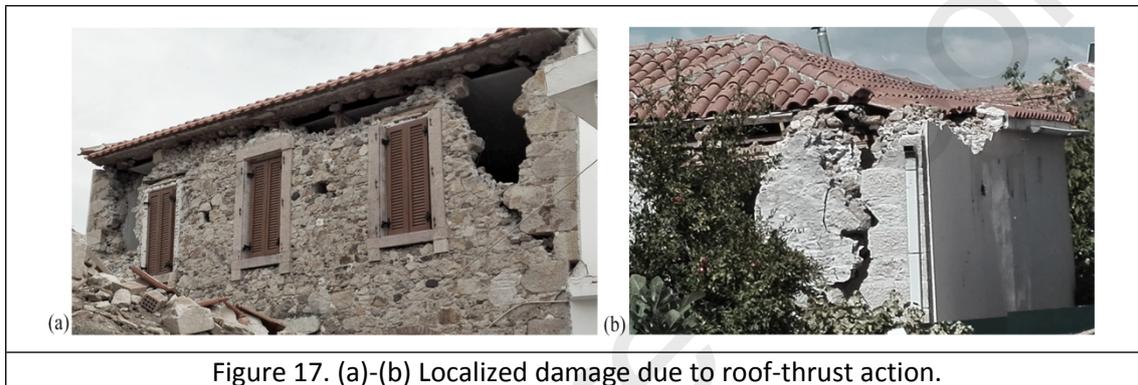
Figure 17. (a)-(b) Localized damage due to roof-thrust action.

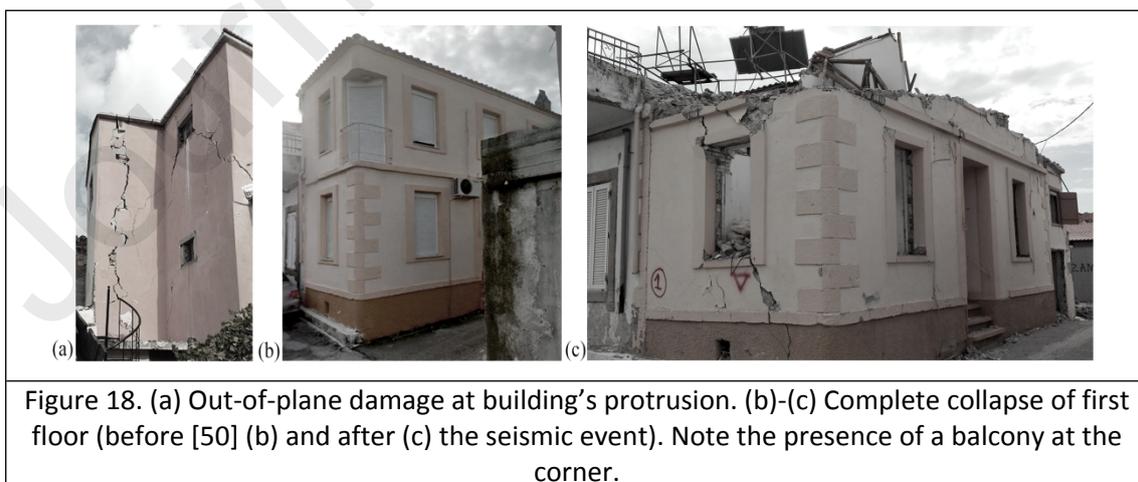
342 Plan irregularities led also to OOP mechanisms. Figure 18 (a) shows a protrusion of a building
 343 that concentrated severe damage due to torsional phenomena taking place. Figure 18 (b)-(c)
 344 displays a case of complete collapse of the first floor. By looking to its condition before the
 345 seismic event, it appears that the owners demolished the corner of the building at the first
 346 floor in order to create a balcony. This eliminated any connection of the transversal walls
 347 and introduced a plan irregularity, certainly contributing to collapse.

Figure 18. (a) Out-of-plane damage at building's protrusion. (b)-(c) Complete collapse of first floor (before [50] (b) and after (c) the seismic event). Note the presence of a balcony at the corner.

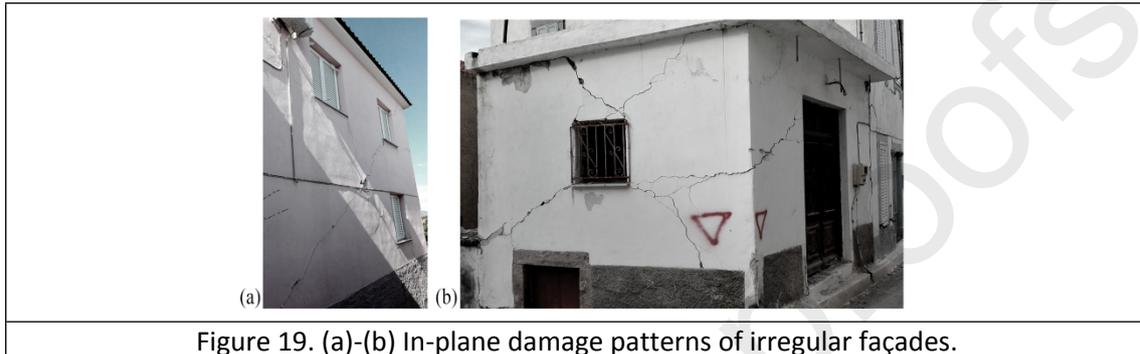
356 In most buildings where the plan and elevation regularity is respected, damage is distributed
357 in the so-called masonry members, i.e. the piers and spandrels. On the other hand, buildings
358 with irregular configuration exhibit damage concentration at the weakest areas (Figure 19).

Figure 19. (a)-(b) In-plane damage patterns of irregular façades.

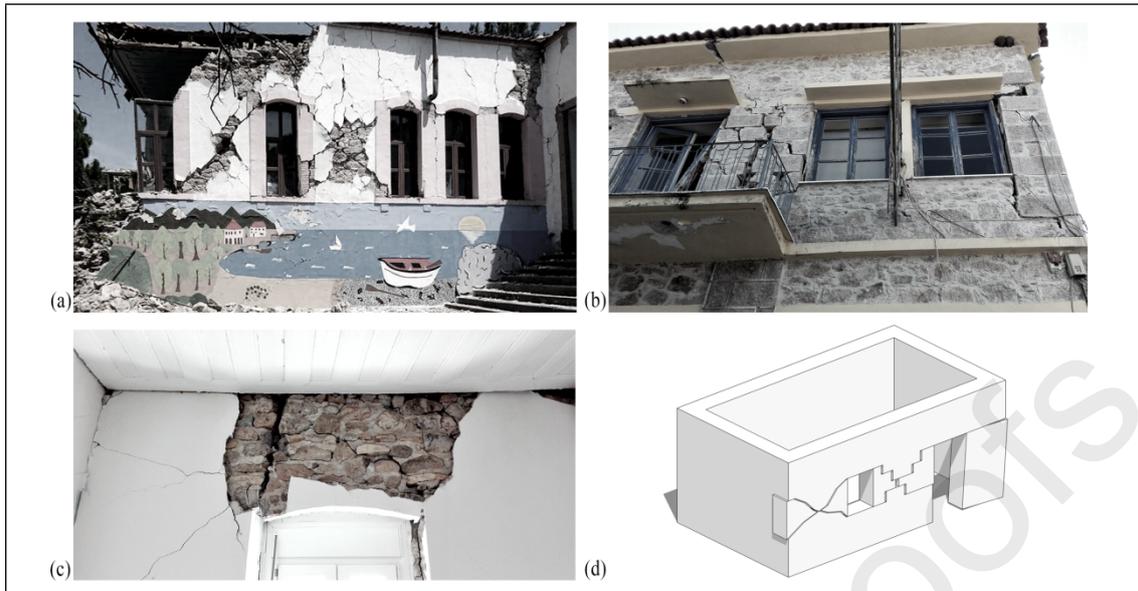
370 until toe crushing occurs. Finally, any combination of the aforementioned modes is
371 commonly observed, especially after cyclic loading reversals. Figure 20 illustrates
372 representative cases of the aforementioned IP damage patterns.

Figure 20. Typical in-plane damage pattern of: diagonal tension (two piers at the left of (a)), joint sliding (left pier of (b) and spandrel of (c)), flexural (right piers of (a), right pier of (b) and spandrel of (c)). Note that (a) shows the side façade of the elementary school of Vrissa settlement. (d) Schematic sketch of in-plane damage patterns.

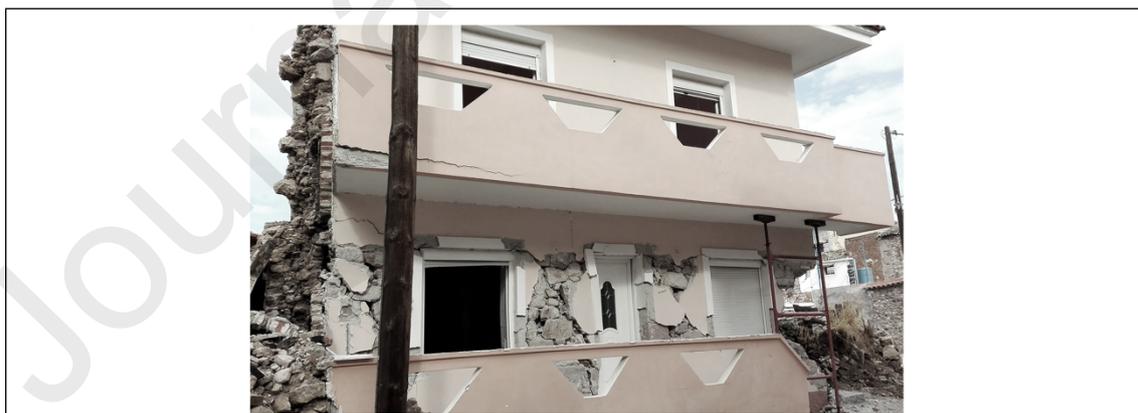
374 As expected, URM structures that experienced IP damage were mostly cases with a
 375 Reinforced Concrete (RC) slab (Figure 19 (a)-(b), Figure 20 (b), Figure 21). By its inherent
 376 stiffness, the slab acts as a diaphragm and thus prevents OOP mechanisms. Nevertheless, it
 377 should not be disregarded that RC slabs possess significant weight and therefore increases
 378 also, moderately, the seismic demand (in masonry buildings most of the weight remains in
 379 the walls). Figure 21 illustrates a building with particularly large mass due to the RC slabs
 380 that even extend to balconies, with severe IP damage in the ground floor.

Figure 21. Severe in-plane shear damage at the ground floor of a building with large mass in the reinforced concrete floor slabs.

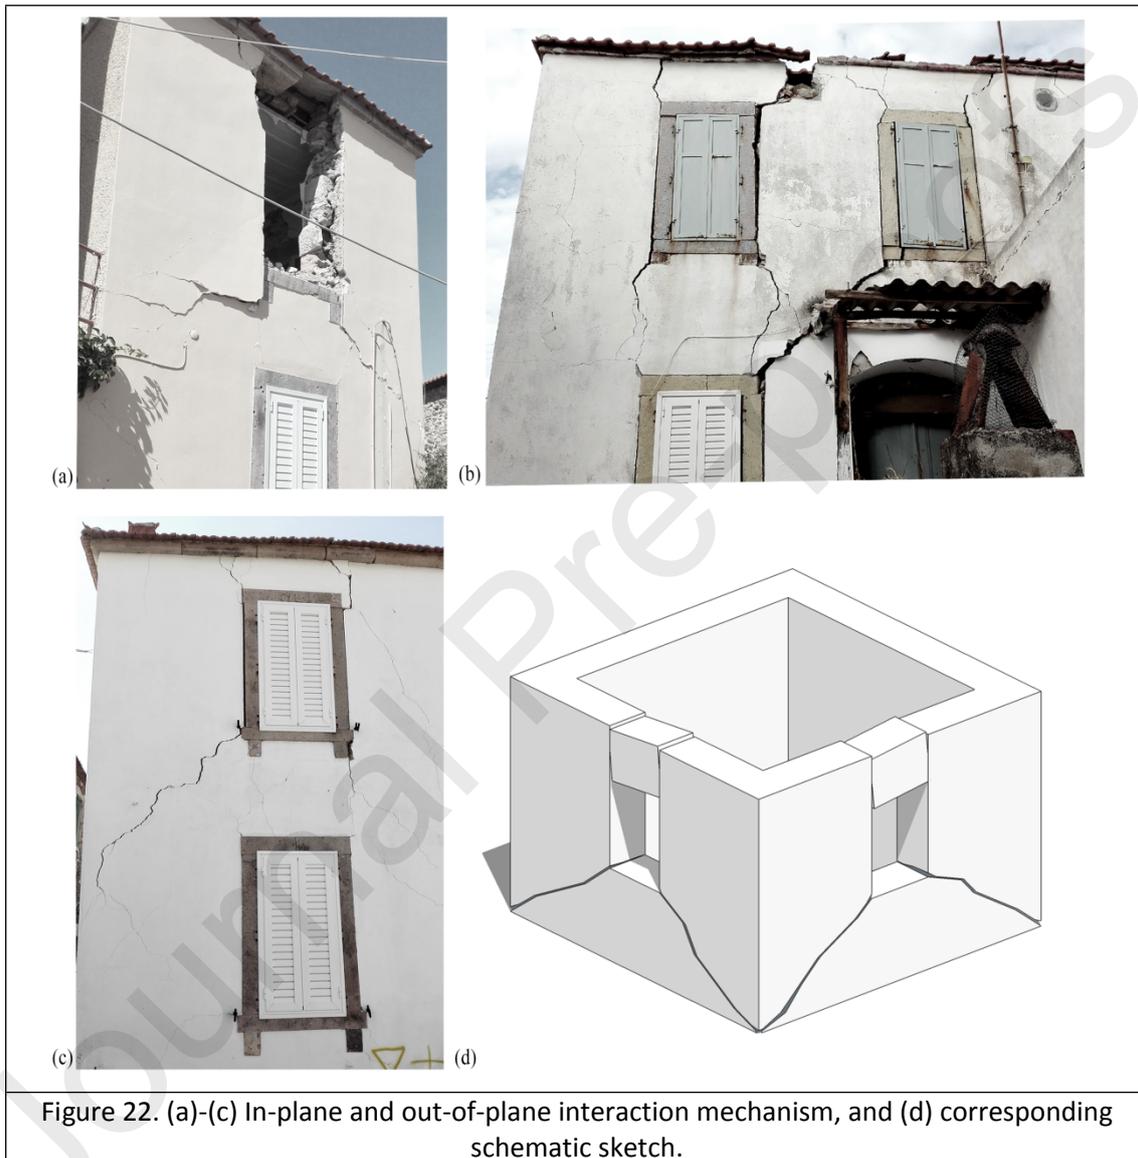
386 The most frequent combined mechanism was the interaction, leading to both: 1) vertical
 387 cracks at the end sections of the spandrels that derive from the IP flexure of the spandrel
 388 and the OOP response of the façade; 2) diagonal cracks at the lower corners of the openings
 389 propagating towards the corners of the structure, that arise by the IP shear damage and the
 390 OOP behavior of the façade (Figure 22). An additional characteristic of this mechanism is
 391 that in most cases it appears mirrored in the transversal façades. The corner mechanism,
 392 mentioned in Section 3.1, is a local manifestation of this mechanism.

Figure 22. (a)-(c) In-plane and out-of-plane interaction mechanism, and (d) corresponding schematic sketch.

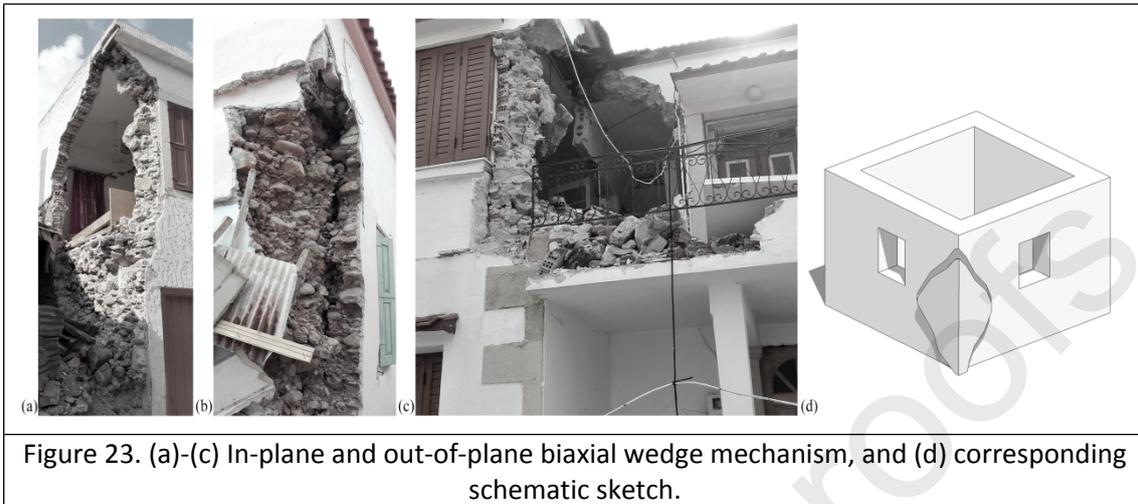
394 Observed only in a few cases, another identified combined mechanism was the wedge
 395 biaxial failure. This appears as a second order mechanism of the previous combined, when
 396 the top part of the construction is restrained. Under this condition, a wedge (usually the
 397 corner of the building) is highly stressed by the biaxial actions up to its capacity, resulting in
 398 a bursting collapse (Figure 23). In case of corners, the failure surface forms a rhombus that
 399 expands over the two transversal walls. In addition, this mechanism was also observed at
 400 the recess corner of a plan-irregular structure, where high biaxial stresses concentrated

401 (Figure 23 (c)). It may be worth mentioning that cut corners, a commonly observed
402 functional detail for street widening (e.g. see the bottom part of the corner at Figure 5 (a)),
403 significantly reduce the capacity of this mechanism.

Figure 23. (a)-(c) In-plane and out-of-plane biaxial wedge mechanism, and (d) corresponding schematic sketch.

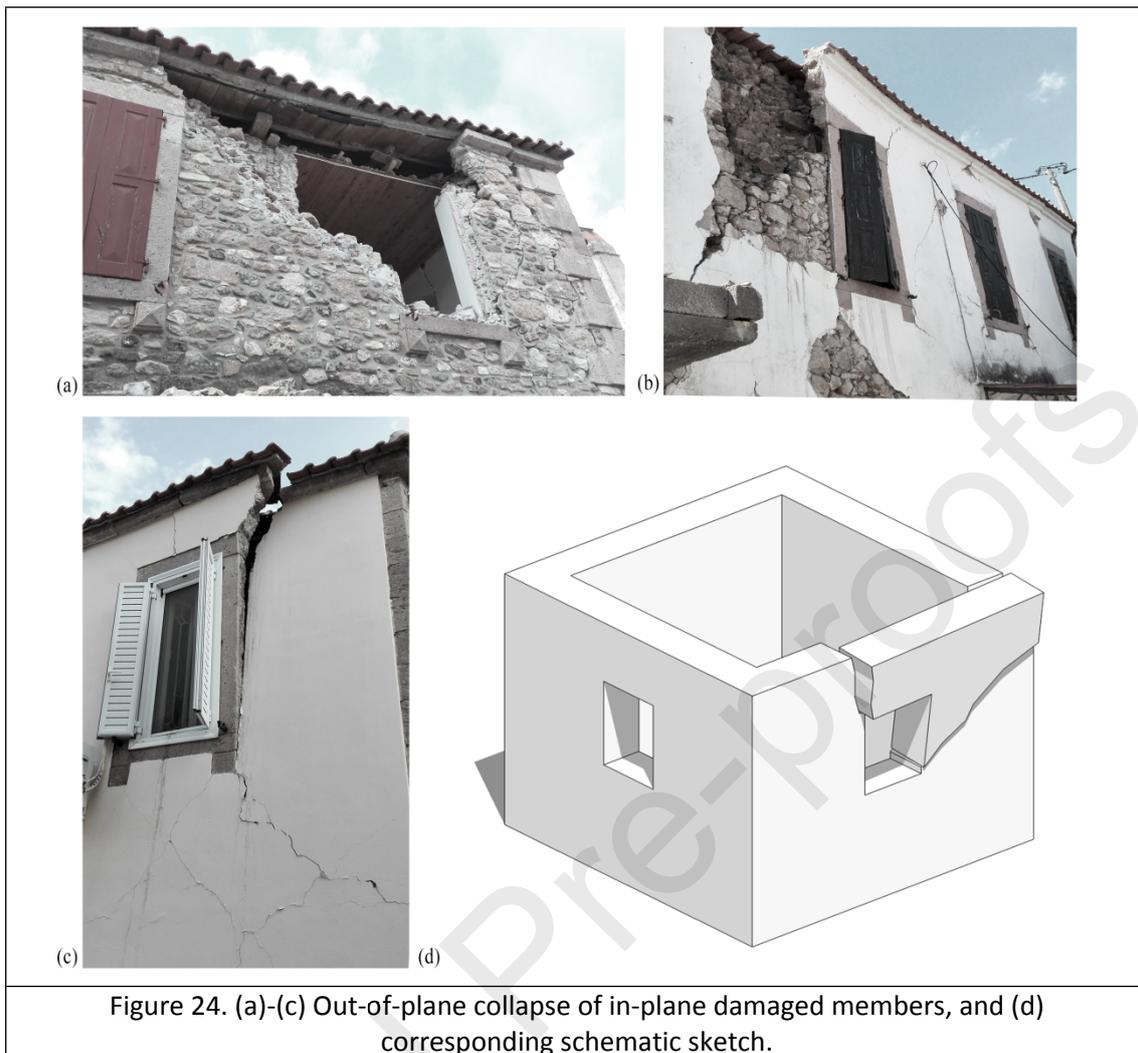
405 Another combined mechanism observed was the OOP collapse of a previously IP damaged
406 wall. This mechanism refers to the strength degradation induced by IP damage to a portion
407 of the masonry wall, which may then be isolated and overturned by OOP actions (Figure 24).
408 The reverse situation was not observed in the field reconnaissance, but it should not be
409 excluded.

Figure 24. (a)-(c) Out-of-plane collapse of in-plane damaged members, and (d) corresponding schematic sketch.

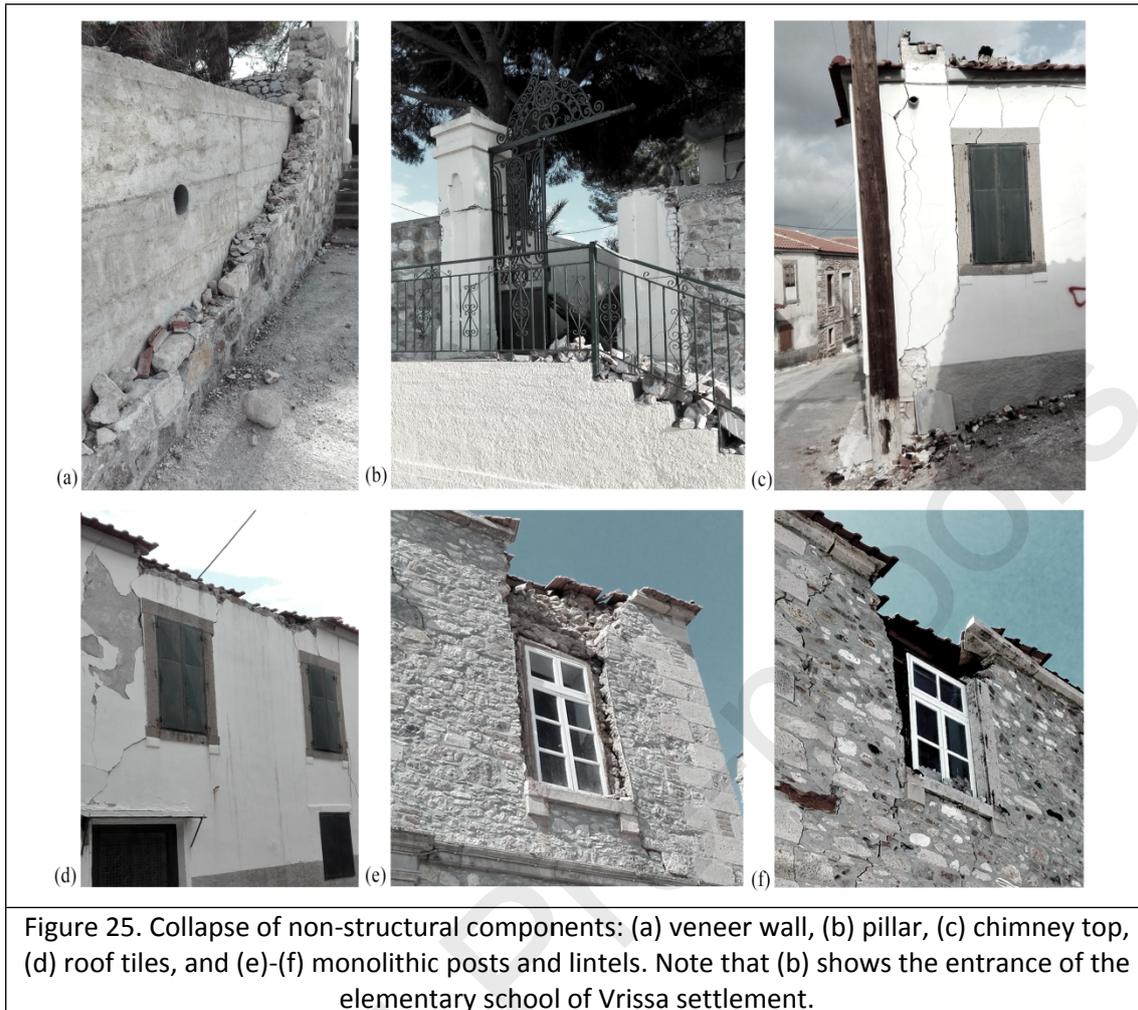
414 Similarly with previous earthquake reconnaissance, collapses were observed in retaining and
 415 veneer walls (Figure 25 (a)), pillars (Figure 25 (b)), chimney tops (Figure 25 (c)), roof tiles
 416 (Figure 25 (d)) and infilled window openings. Yet the most crucial and widespread of non-
 417 structural failures appeared to be the monolithic stones used for posts and lintels of the
 418 openings (Figure 25 (e), (f)). As discussed in Section 2.2.1, this local architectural feature of
 419 the settlement did not possess any connection or interlocking with the rest of masonry and
 420 thus detached easily. More importantly, collapse could undoubtedly lead to fatalities, as
 421 massive stones collapsed at the entrance of the buildings and in the streets during the
 422 seismic event.

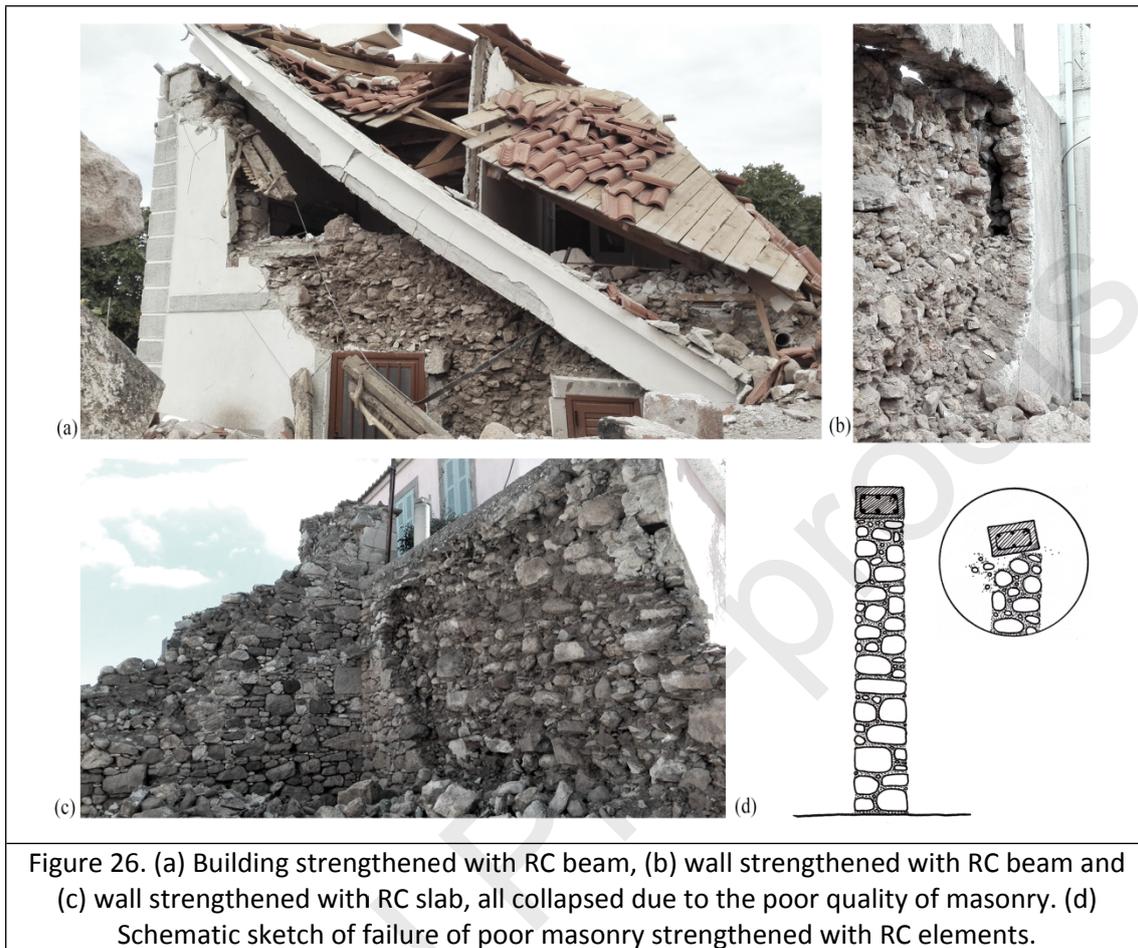
468 Several cases were identified in which a RC beam was introduced at the top of masonry
469 walls (Figure 26 (a), (b)). This strengthening technique falls in the second category and could
470 be beneficial, as it connects and ties the transversal walls (and may add overburden weight),
471 thus reducing the OOP vulnerability of the façades. Nevertheless, local or even global
472 collapses were observed in such cases, with the masonry walls disintegrating (“zero”
473 mechanism). Given the extremely poor quality of masonry, the integrity of the underlying
474 walls was not ensured in order for the enhanced connections to be beneficial. In addition,
475 one could argue about the damage introduced by adding the beam or the subsequent
476 incompatibility of deformation, and about an increase in the demand of the poor masonry
477 walls, due to the added mass of the RC elements, or the destabilizing OOP moments that

481 response of the underlying poor masonry. Had the masonry's integrity been ensured, the
 482 diaphragm could be beneficial.

Figure 26. (a) Building strengthened with RC beam, (b) wall strengthened with RC beam and (c) wall strengthened with RC slab, all collapsed due to the poor quality of masonry. (d) Schematic sketch of failure of poor masonry strengthened with RC elements.

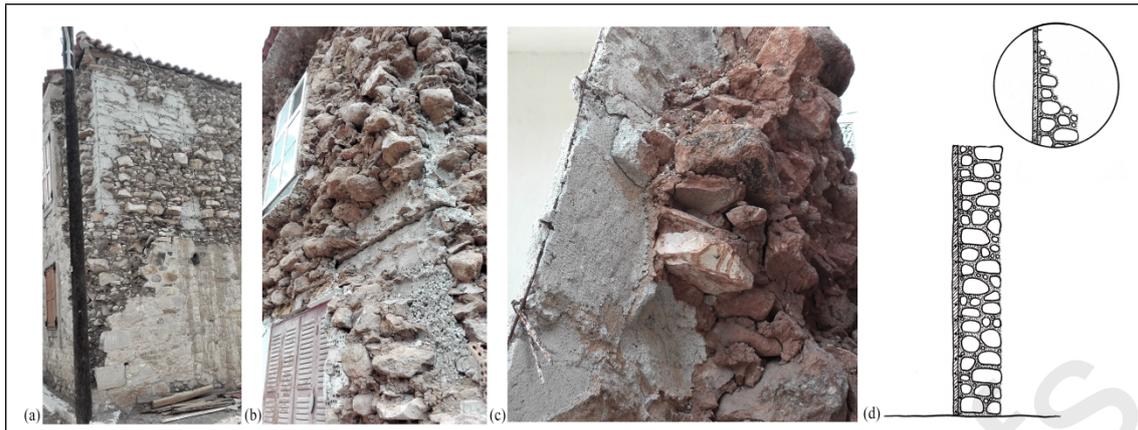
484 Finally, a few cases of RC jacketing were observed. This strengthening technique falls in the
 485 third category, as it intends to increase the capacity and stiffness of the masonry walls, both
 486 for IP and OOP actions. However, as the application was once more over a poor masonry
 487 substrate, failure and collapse were found (Figure 27). At this point it is interesting to note
 488 that if a proper detailing is performed, with applications on both sides of the walls and well-
 489 designed anchors, RC jacketing could act beneficially also for the integrity of the masonry,
 490 i.e. the first category. Nevertheless, very deficient applications of this strengthening
 491 technique were found (Figure 27 (c)), as application was only on the internal surface and
 492 using sparse anchors. The images illustrate clearly that it was masonry that failed rather than
 493 the reinforcement, corroborating the need of prioritization of strengthening interventions.

Figure 27. (a)-(b) Buildings strengthened with RC jacketing, which failed due to the poor quality of masonry. (c) Detail of a collapsed masonry portion strengthened with RC jacketing. (d) Schematic sketch of failure of poor masonry strengthened with RC jacketing on one side.

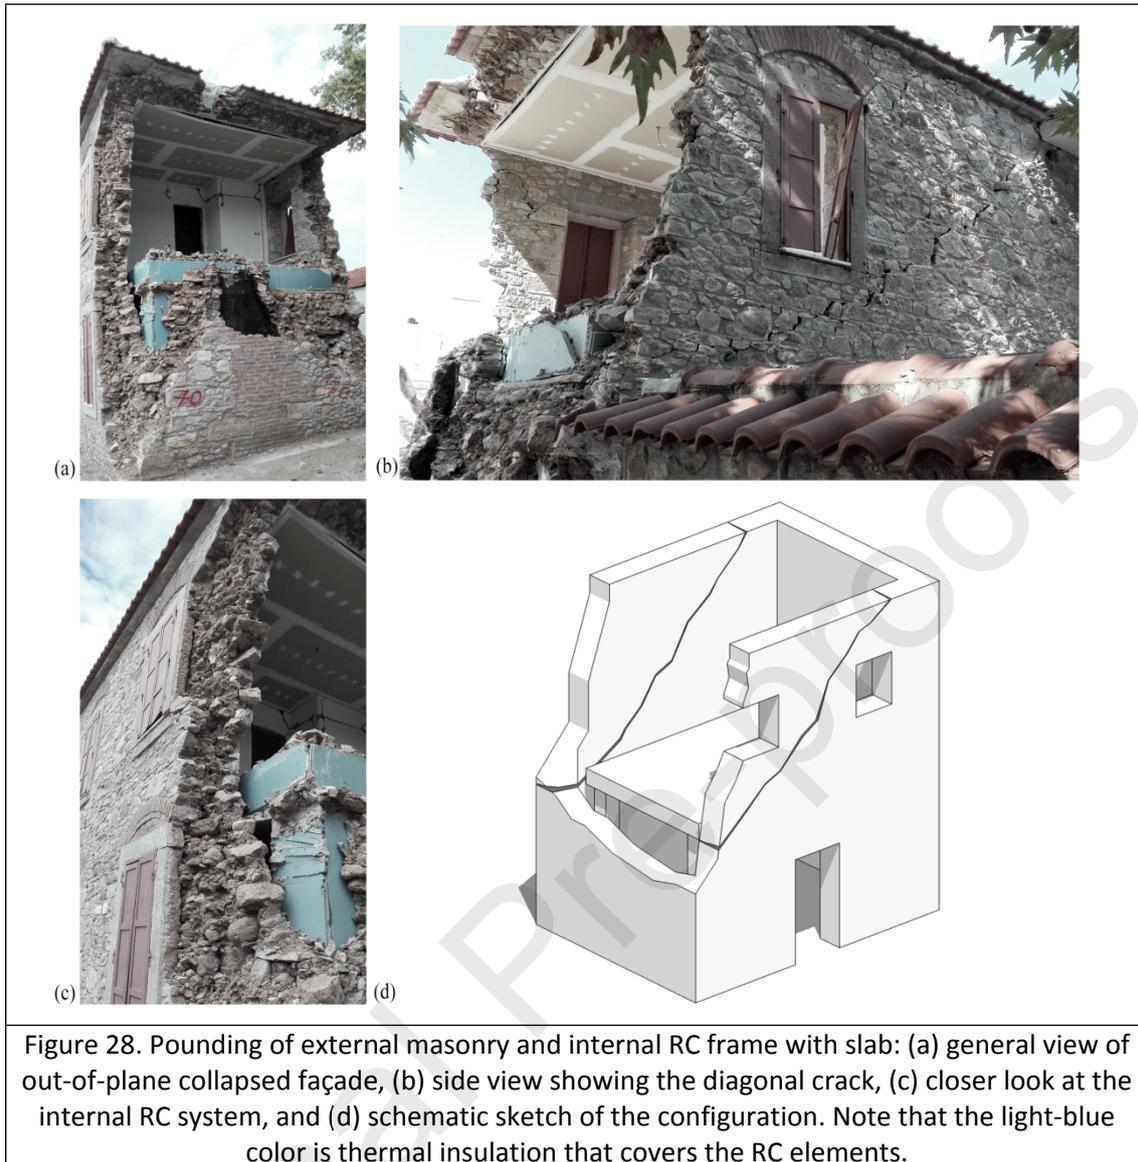
511 walls, inducing severe damage instead of providing strengthening to the existing structure.
 512 In fact, the failure mechanism of the masonry structure observed highlights the behavior, as
 513 the collapsed façade failed under OOP actions exactly at the height of the slab, while the two
 514 transversal walls suffered IP damage that initiated at the aforementioned height and
 515 propagated diagonally, ignoring the openings' layout.

811 Finally, the second case concerns the building presented in Section 4.2 and Figure 28. The
812 observations made there indicate that pounding occurred between the internal RC frame
813 and slab with the external masonry façade. By looking at the damage pattern it is clear that
814 the collision happened at the interface between the slab and the façade that collapsed OOP,
815 while the transversal façades showed only IP damage induced by the previous collision. The
816 façade that collapsed faces SE, while the two transversal façades face SW and NE. Since
817 pounding occurs at large displacements, the aforementioned damage pattern points out
818 that the main seismic component was in the NW-SE direction.

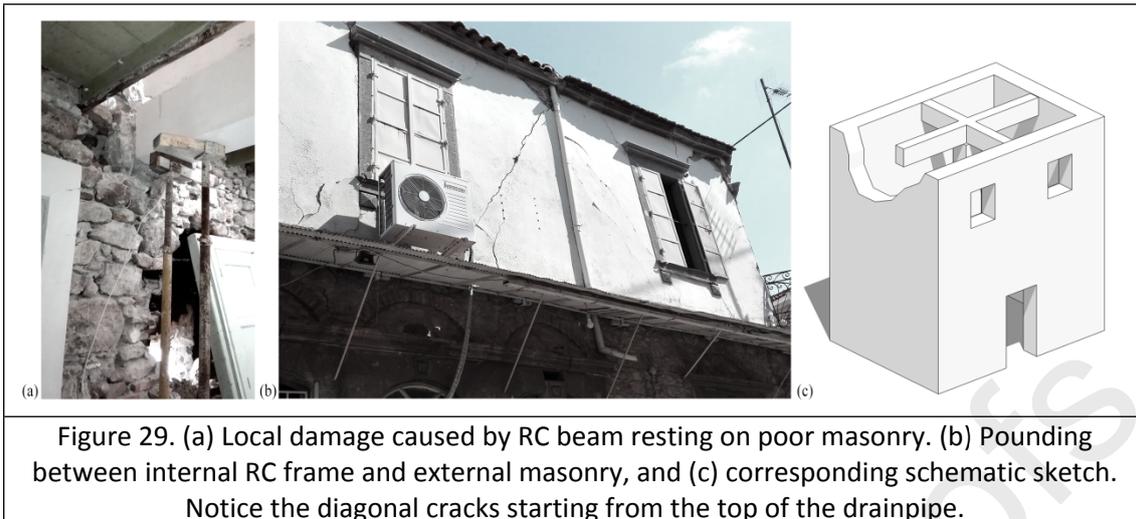
517 A similar intervention scheme inspected included RC columns and beams, the latter resting
 518 on the peripheral masonry façades. In this case, a proper connection among the new RC
 519 beams and the masonry walls was not ensured, resulting into two main damage patterns: 1)
 520 in cases of poor quality of masonry, the concentrated loads caused local disintegration of
 521 masonry (Figure 29 (a)); 2) pounding between masonry and the concrete beams caused
 522 damage to the façades (Figure 29 (b), (c)).

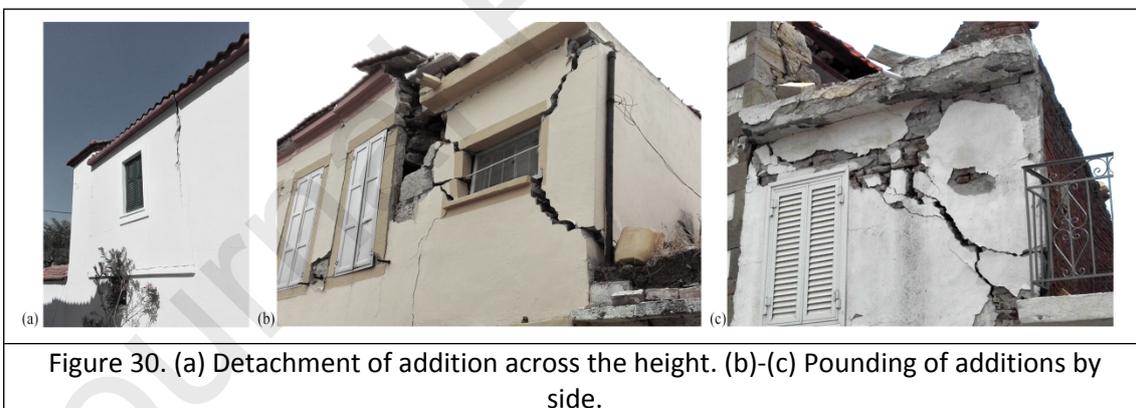
527 Finally, small additions are also a common intervention practice to increase the housing
 528 space. Additions across the height (in elevation) were observed in some cases to suffer
 529 detachment and potential overturning (Figure 30 (a)). Additions by side (in plan) often acted
 530 beneficially as a buttressing element, constraining the OOP failure. Nevertheless, pounding
 531 between the old masonry and the side addition was also identified (Figure 30 (b), (c)).
