Learning from failure: Damage and Failure of Masonry Structures, after the 2017 Lesvos Earthquake (Greece)

Georgios Vlachakis, Evangelia Vlachaki, Paulo B. Lourenço

To appear in: *Engineering Failure Analysis*

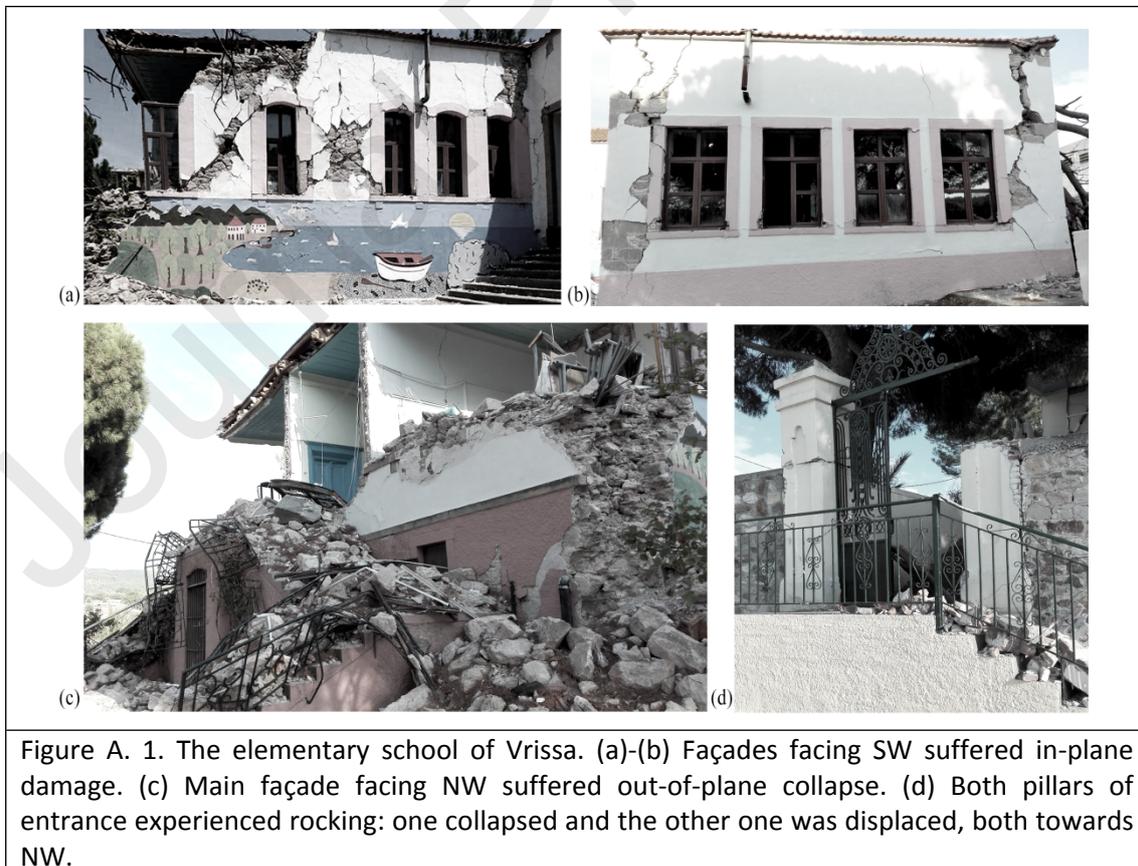
807 direction. In fact, a local landslide occurred at the NE side and the corresponding façade (not
808 showed herein) collapsed OOP. Nevertheless, all the rest façades and the pillars of the
809 entrance point out the same seismic motion directivity towards NW.
