Learning from failure: Damage and Failure of Masonry Structures, after the 2017 Lesvos Earthquake (Greece)

Georgios Vlachakis, Evangelia Vlachaki, Paulo B. Lourenço

To appear in: *Engineering Failure Analysis*

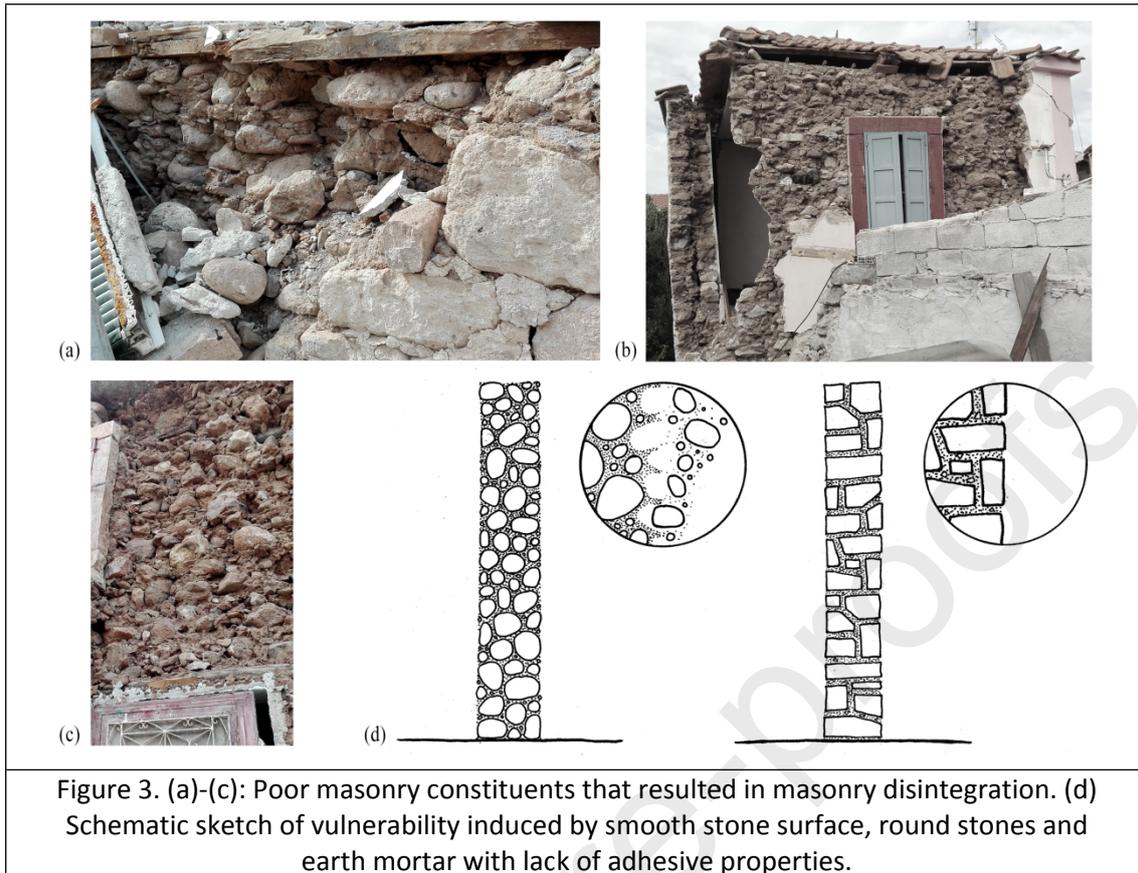
145 In general, materials of poor quality were used in the masonry construction, resulting in
146 remarkably low seismic performance. Despite the good quality of ignimbrite stones
147 extracted at quarries in the surrounding area and the local brick manufactories, many of the
148 structural walls in the Vrissa settlement were built of relatively small river-side stones (i.e.
149 dimension smaller than 0.20 m), due to their abundant presence nearby and the ease of
150 collection. The smooth and round surface of such stones did not allow significant bond and
151 interlocking to be developed and structural walls disintegrated easily (Figure 3). Earth
152 mortar was mainly used in the masonry buildings, introducing further vulnerability. Such
153 mortar is characterized by low cohesive properties, low compressive strength and sensitivity
154 to water content (Figure 3). Lime and cement based mortars were also employed, but only

159 Material degradation contributed in worsening the performance of both masonry and
160 timber elements. The abandonment that the Greek countryside experienced in the last
161 decades resulted in substandard or lack of maintenance. Water ingress deteriorated both
162 the mortar and the timber elements.

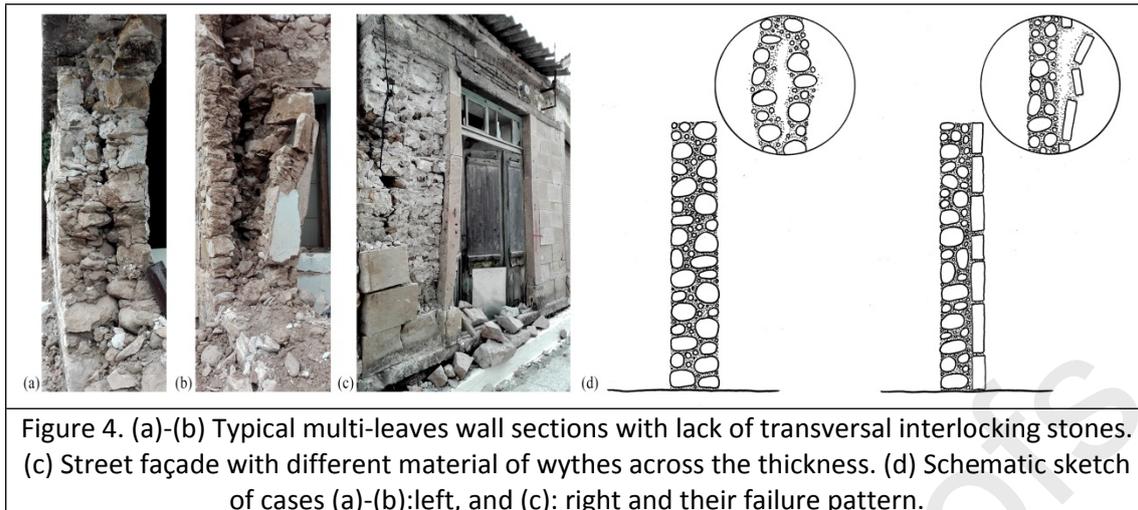
168 UnReinforced Masonry (URM) buildings were constructed typically with two and three-leaf
 169 masonry walls with a thickness varying between 0.4 and 0.7 m. However, the lack of
 170 transversal interlocking stones (through stones, bond stones, tie stones or *diatono*) that
 171 could connect the external leaves, resulted in detachment and masonry delamination
 172 (Figure 3 (b), (c), Figure 4 (a), (b), (d)). This construction deficiency appeared to be crucial for
 173 the seismic response of the URM buildings, as it triggered or assisted many structural
 174 failures, as shown below.

175 In some structures built at the central part of the settlement, a different kind of building
 176 material was used between the parallel leaves. Perfectly cut stones were employed for the
 177 outer leaf of the façade in order to demonstrate wealth and solidity, while rubble stones
 178 were used for the rest of the section (Figure 4 (c), (d)). Once again, no mechanical
 179 connection between the leaves was ensured, while the different stiffness of the masonry
 180 across the section increased its vulnerability.

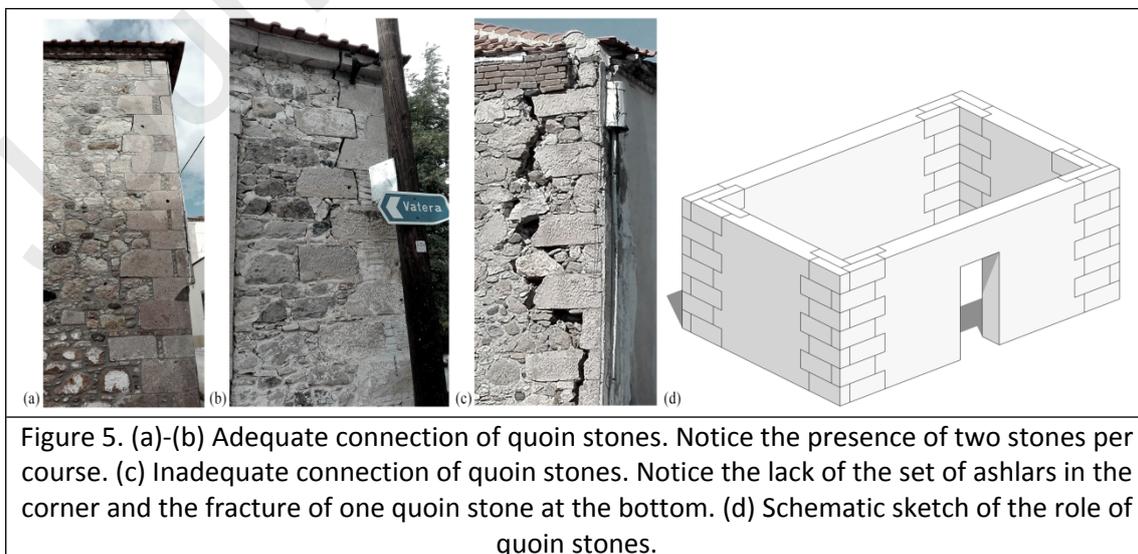
182 The corners of URM buildings were usually constructed with quoin-stones. Well-shaped and
 183 in most cases, being made with more than a single stone in the course, quoins helped the
 184 connection of transversal walls, preventing local or global failures (Figure 5 (a), (b), (d)), as
 185 shown below. Still, quoins were often insufficient to prevent the development of corner
 186 cracks, especially when an additional set of ashlar stones was poorly constructed or missing
 187 (Figure 5 (c)). The use of ashlar stones was also adopted for the stones in the frames around
 188 building openings. Often, monolithic squared stones were used for posts and lintels around
 189 the openings, as a local architectural feature. The lack of proper interlocking of these
 190 elements with the rest of the masonry, leads to the assumption that these are decorative,
 191 non-structural elements.

309 Furthermore, the presence of transversal walls is not a *de facto* guarantee of their
 310 effectiveness. An adequate connection capacity is required in order to distribute the inertia
 311 forces of the OOP façade to the in-plane walls, typically ensured by quoin-stones (Figure 5),
 312 timber-laces (Figure 6) or tie rods (Figure 9 (c)). The importance of the corner connections
 313 was appreciated by local masons, as it can be recognized by observing the existing
 314 construction details. However, in several buildings the quoins were not sufficient, especially
 315 when the second set of stones in a course was poorly constructed or missing, making a short
 316 connection. Moreover, the presence of openings at the proximity of the corners appeared to
 317 reduce the strength of the corner connections (Figure 14). In the same context of lateral
 318 support, the architectural feature of buildings' entrance with a recess door acted beneficially

401 (Figure 23 (c)). It may be worth mentioning that cut corners, a commonly observed
402 functional detail for street widening (e.g. see the bottom part of the corner at Figure 5 (a)),
403 significantly reduce the capacity of this mechanism.

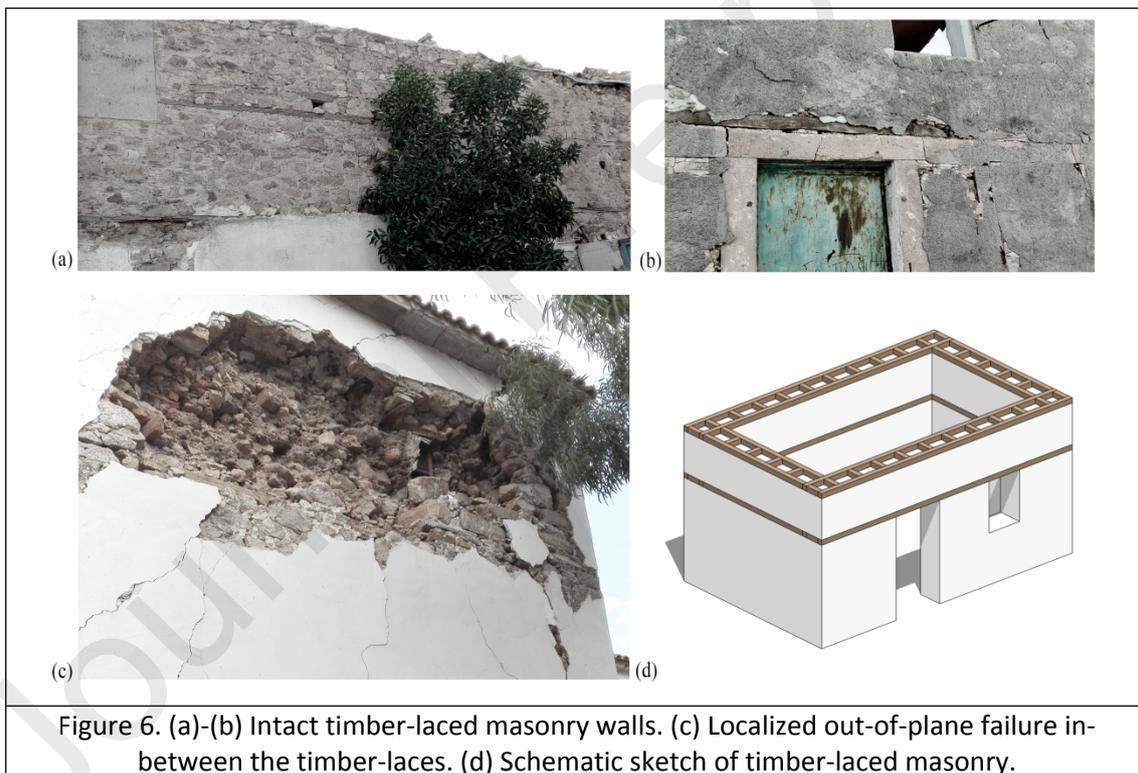
203 *Timber-laced masonry* consists of timber ring beams placed at regular spacing across the
 204 height and as a pair across the thickness of the walls (Figure 6). Such a technique, as
 205 described in [41–44] and references therein, improves the seismic performance of the
 206 building in its inelastic range, by providing horizontal slip planes, dissipating energy and
 207 enhancing the masonry In-Plane (IP) and Out-Of-Plane (OOP) strength by confining portions
 208 of the walls. In addition, this technique enhances the connection between transversal walls
 209 and helps to tie the leaves of a wall together and avoid disintegration. During the
 210 reconnaissance campaign, the damage that was observed in timber-laced masonry
 211 structures was limited in-between the ring-beams across the height, demonstrating the
 212 adequacy of the system (Figure 6 (c)).
